August 8, 2013

June 25 and July 16, 2013 Inspectors: David Schmerge – USFS  
David Wilfong – ADNR

July 29, 2013 Inspectors: David Schmerge – USFS  
Jill Weitz – ADEC  
David Wilfong – ADNR

## Inspections of the Kensington Gold Mine

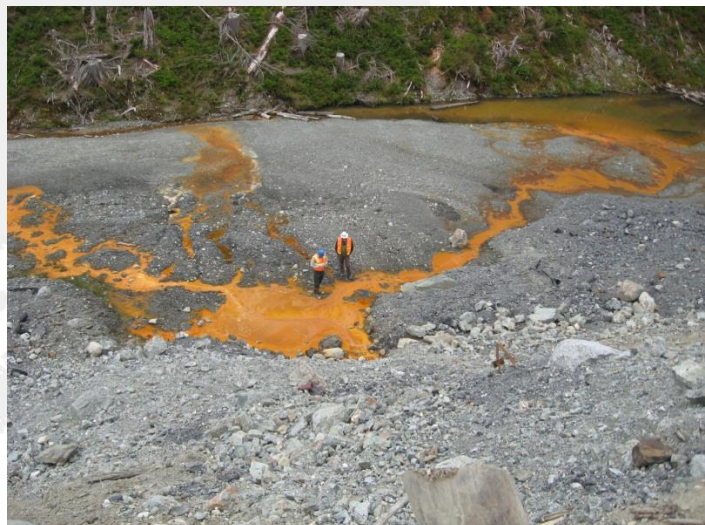
Figure 1 Staining due to metals leaching from low pH water.

Some of the acid generating graphitic phyllite material was mixed with other fill for unknown reasons during last summer's construction of the second stage of the downstream dam raise, and placed into a non-lined area of the TTF. Water quality tests showed that the resulting drainage from the area contained high levels of metals and a low pH as seen in Figure 1.

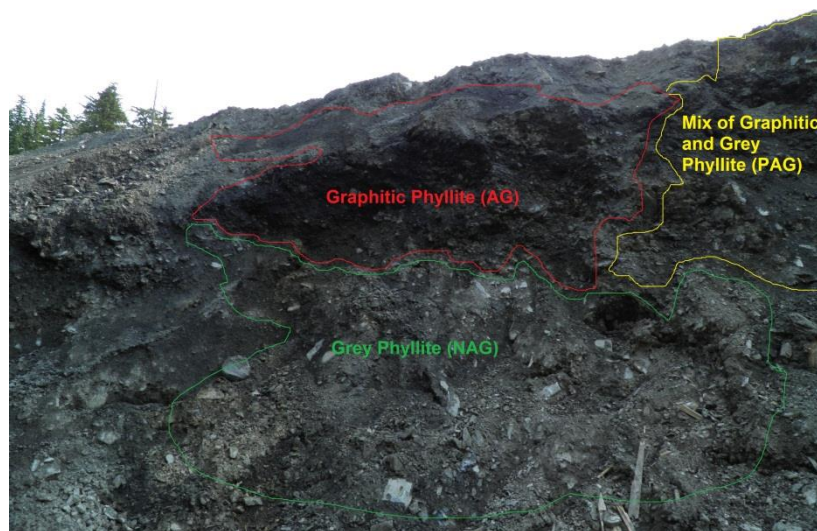
Coeur submitted a proposed remediation plan to remove the acid generating material and the plan was approved by the agencies near the middle of June. While the material is clearly observable by its black color (Figure 2), it was found to be too homogeneously mixed with the other fill material in the area, and the entire volume of fill had to be excavated and placed in containment to avoid any future releases of water with poor quality.

**Figure 2** Outlines are for reference only and are not an accurate representation of the location or dissemination of the graphitic phyllite.

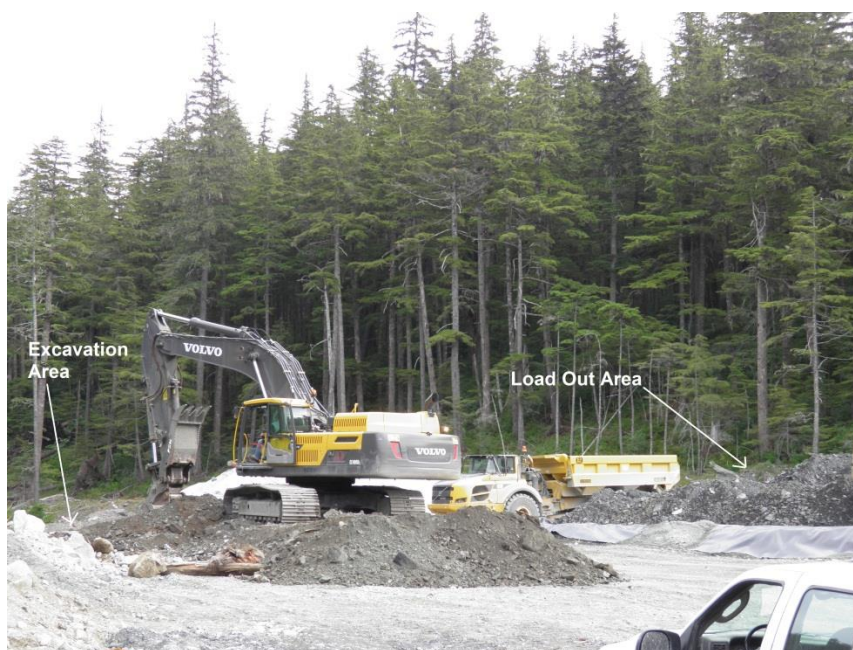
Figure 3 Equipment used to load and haul the graphitic phyllite.

During the June 25<sup>th</sup> inspection, a Volvo EC480DL Excavator was actively digging material from the embankment and placing it into a lined load out area. From there, it was loaded into one of two Volvo A30F 30 ton articulating underground haul trucks.

June 25 inspection, and the removal procedure had begun (Figure 3). Water management is a key component of mitigating the effects of the ARD. While the effects of the drainage are limited to the containment of the TTF, the Lower Slate Lake Water Treatment Plant (WTP) is not designed to treat ARD. A small ARD treatment plant that manages the effluent from the graphitic phyllite deposit is located at the south end of the TTF. Water is collected in ponds, sumps and caissons at the north end of the TTF, collected and pumped into an HDPE lined storage pond in a central location. When the storage pond is full, it is pumped into a tanker truck, and hauled to the ARD treatment plant. On July 16, an electric sump-pump was transferring water from a small natural drainage up to the ARD collection pond, but the hose was damaged and leaking as can be seen in figure 4.

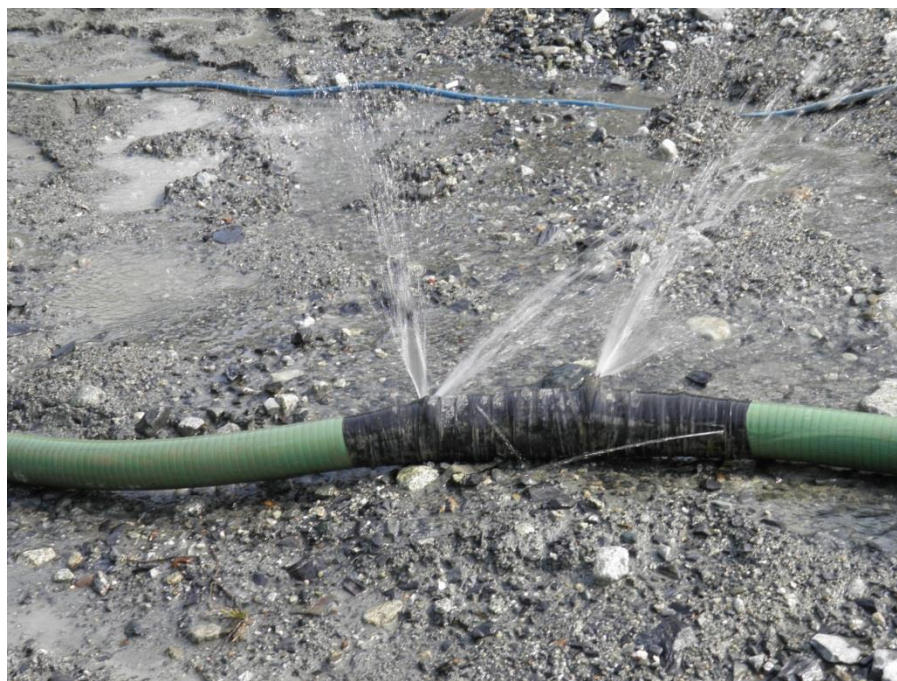
Figure 4 The hose had been mended, but the repair was insufficient.

The substantial head pressure in the hose caused the leak to diminish the flow to the top of the hill, and the flow into the ARD pond had slowed to a trickle. The low pH water flowing from the damaged hose returned to the pond in which it came from where it was collected and pumped back into the leaking hose. Kevin was alerted to the problem. During the July 29 visit, it was noted that the hose

had been properly repaired, and the pond had been pumped nearly dry. It was apparent that the re-repaired hose had been effective in moving the poor quality water up the hill where it could be properly managed. Also noted during the July 29 inspection was the construction of a third HDPE lined containment cell in Pit 7 (Figure 5). Two smaller containment cells at the same location were filled to capacity. Substantial progress had been made on the construction of the third cell. The subgrade had been prepared, the HDPE liner welded, and a sandy gravel layer had been placed on top of the liner to reduce the risk of the 30 ton haul trucks causing damage to it.

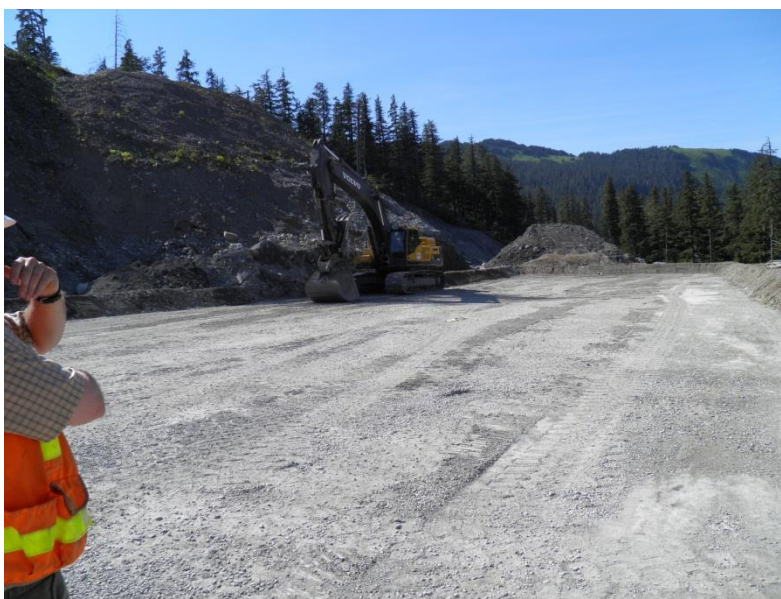
Figure 5 Containment cell near completion.

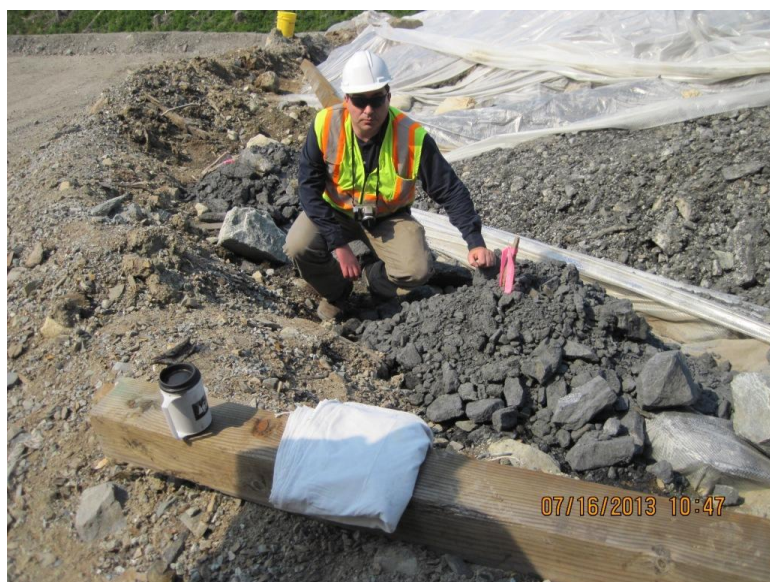
**Figure 6 Segregated pile of graphitic phyllite. The large pieces are to be used for testing.**

confirmed in the lab using LECO analysis equipment. As can be seen in in Figure 6, the Piles were well graded, with particle sizes including riprap size chunks and smaller. I expressed my concern that since the humidity cell tests were not producing the expected results due to the small particle size, it was possible that the small particles in the piles may have skewed the results of the barrel tests. After consulting with Golder, the large chunks were separated out and the fines were washed from them, and only the large pieces would be used in the long term barrel tests.

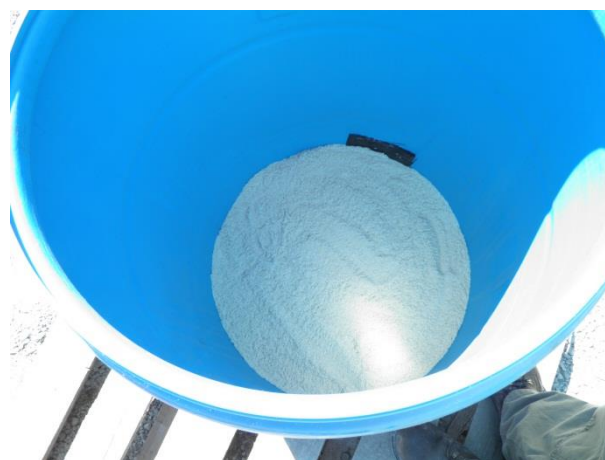
**Figure 7 Outlet covered with geotextile at the bottom of the barrel. About 2 more inches of sand was added.**

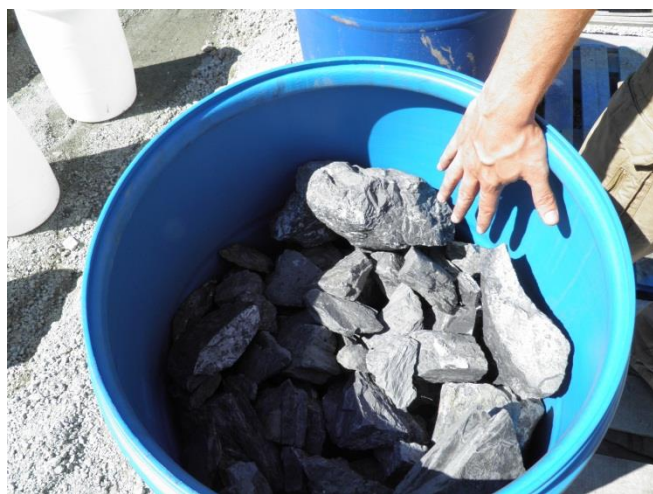
**Figure 8 Filled barrel.**

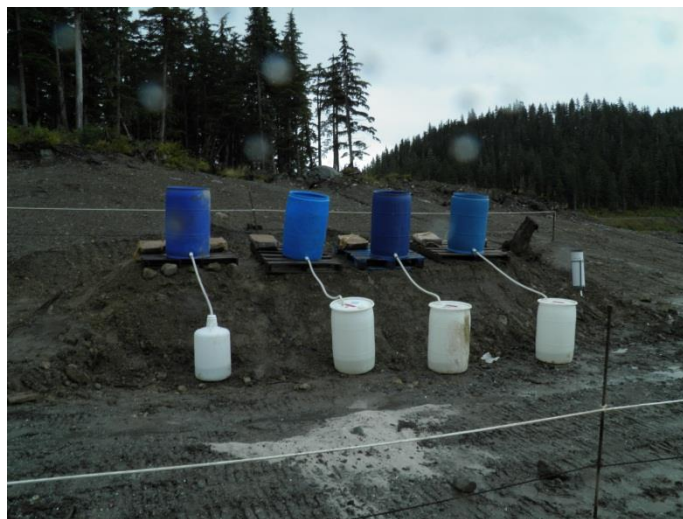
Figure 9 Completed barrel test area.

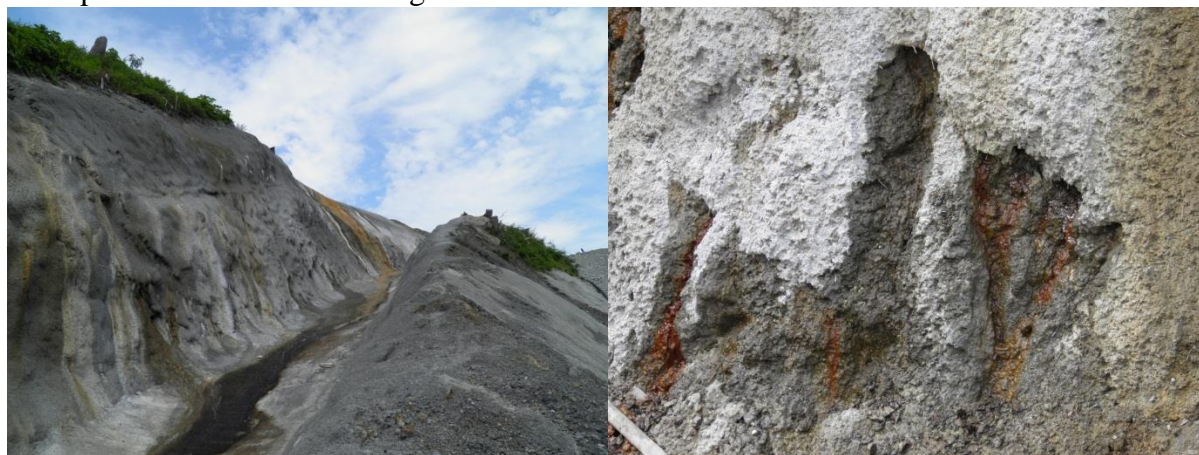
Stage II of the TTF dam was finished in the fall of 2012, and new graphitic phyllite was exposed during the excavation of the dam's foundation. The dam's emergency spillway is located at the west end of the dam. The concrete flume is dug into the GP with shotcrete covering the exposed outcrop of bedrock as seen in Figure 10.

Figure 10 Spillway and shotcrete covering the GP. Low pH water seeping through the shotcrete is eroding it.

In areas of thin or no cover, contact water is exfiltrating through the shotcrete, and draining into the spillway. It flows down the spillway and collects in the plunge pool where it is pumped to a batch ARD water treatment plant. The low pH water reacts with the carbonate in the shotcrete and is actively deteriorating the areas around the seeps. The eroding shotcrete allows the seeps to widen allowing more water to exfiltrate. It is unclear how or if the higher flow rates affect the quality of contact water.

The shotcrete was intended to limit infiltration and exfiltration of oxygen and water into the GP formation, consequently minimizing the production of ARD. It is difficult to gauge how effective the application of shotcrete has been in this role. A dialogue between the agencies and Coeur Alaska has been opened in the past to discuss whether or not the application of shotcrete would be the best alternative at closure. The discussion should be taken up again before the third (final) stage of the dam is built.

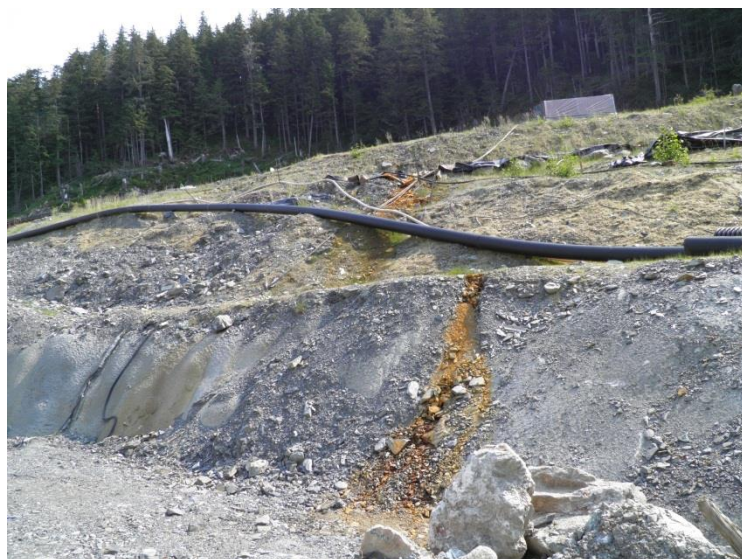
Figure 11 Staining beginning to show near the east end of the dam.

Light staining is beginning to appear on the east side of the dam (Figure 11). The same graphitic phyllite that was uncovered on the west side was excavated on the east side during the initial construction of the dam.

Diorite wasterock was placed in the area to neutralize any acid that may be produced by the disturbed GP, because diorite can have a carbonate content of up to 40 kg CaCO<sub>3</sub>/ton<sup>1</sup>. The staining has not been noted on the east side of the dam on previous inspections. It may be possible that the buffering capacity of the diorite is nearing its end, and low pH effluent with high metals concentration is

surfacing. This is a concern as the only systems in the area to prevent the water from entering Slate Creek are pump-back wells. This area needs to be closely monitored.

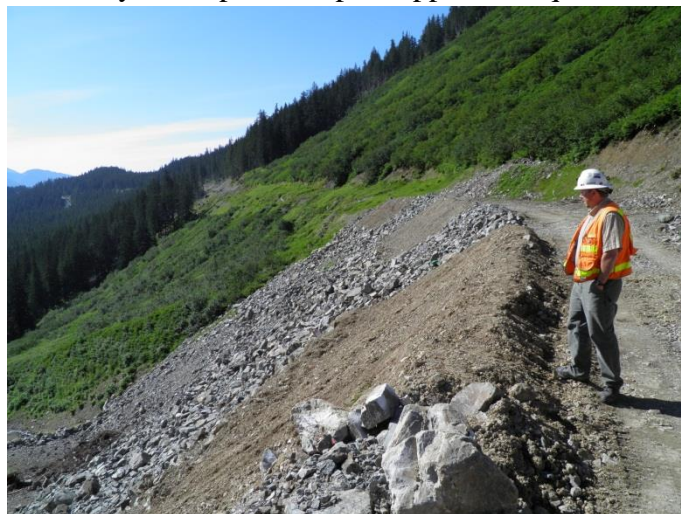
Figure 12 Completed Revegetation Test Plots

Although the construction deadline was surpassed, corrective action was not needed, and while on site on July 29, the plots were visited, and the soil had been spread and seeded according to the approved plan. As stated in the approved Revegetation Test Plot Plan, the same seed mix was used to plant each plot, but different additives were used. One plot used soil with no additive. One plot used a biopolymer designed to deter soil erosion and promote growth. The third plot used fertilizer and mulch spread on the soil with the seed. On July 29, none of the plots showed any growth, so it was too early to make any comparison. Each week, data from each plot is recorded. The results will be used to choose a method for revegetating the site.

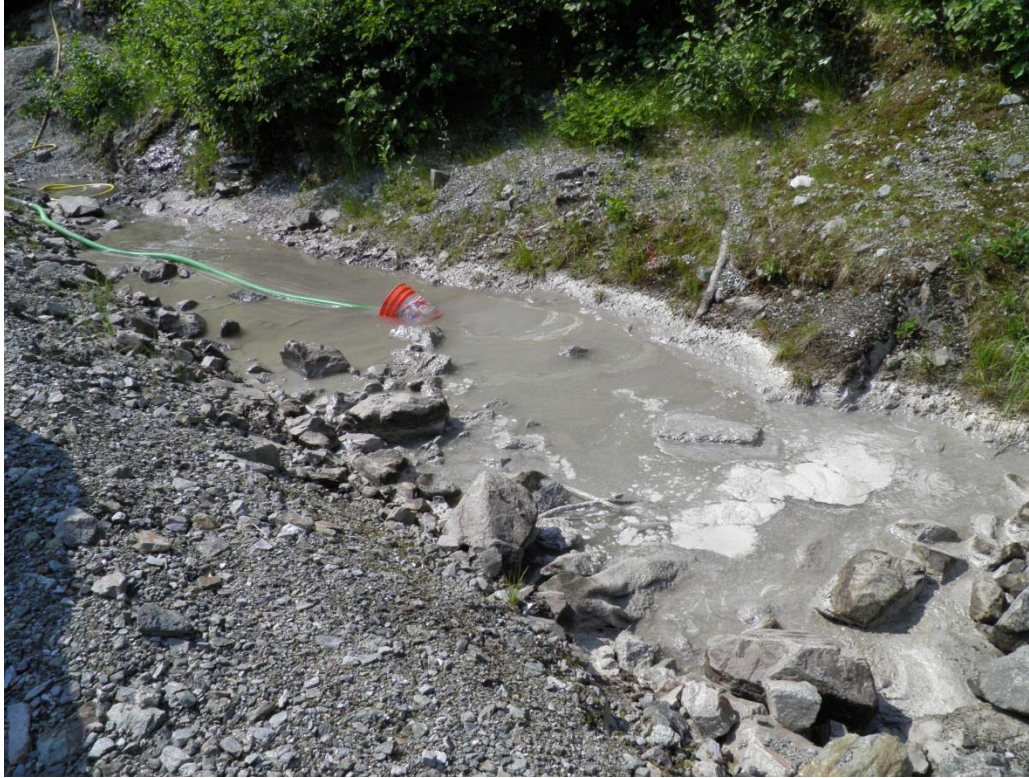
Several surface exploration sites had been chosen by Coeur for the 2013 season. The sites were located both on USFS managed land, and private property. During the June 25 inspection, a core drill rig was positioned directly over a runoff ditch that flowed directly into Johnson Creek. The surface drilling plan of operations (POO) states that no drilling will occur within 200 feet of flowing water, and a pre-shift checklist states that drill water is not to be within 200 feet of flowing water. With the positioning of the drill rig, it was impossible to keep sediment out of the ditch, and hence straight into Johnson Creek. Coeur was alerted to the problem during the inspection, and again during a regular meeting several days later.

Figure 13 Before the culvert was installed.

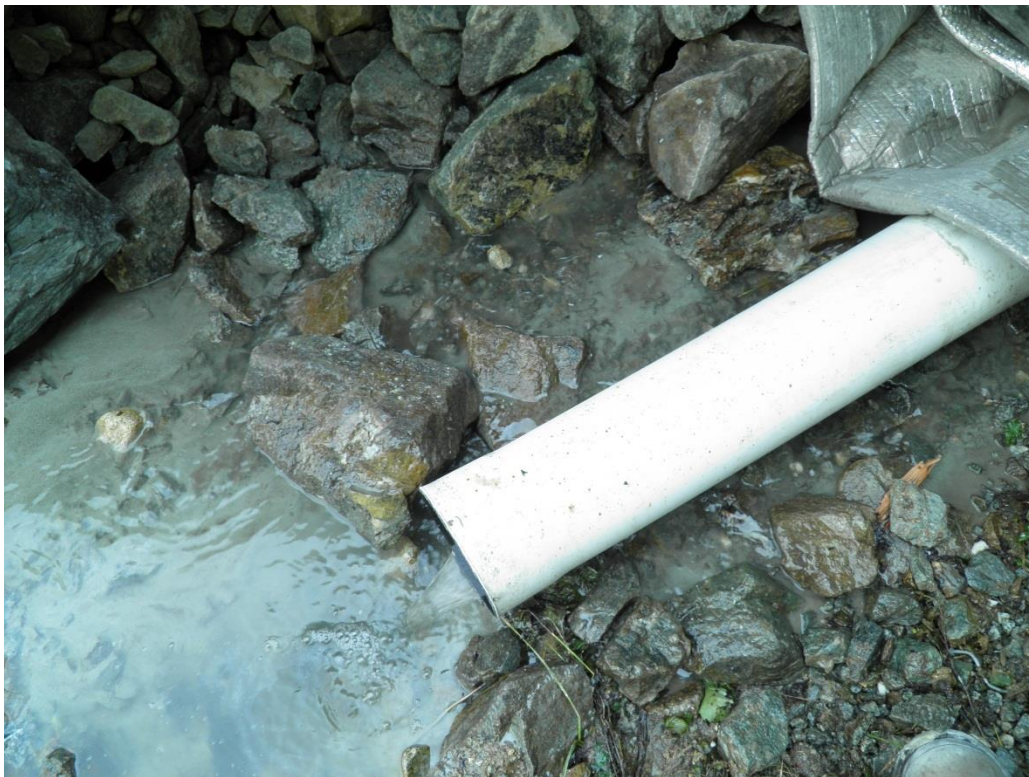
During the next visit, the drill rig was still positioned above the ditch, but a culvert had been installed under the drill so any drill cuttings that escaped containment did not travel downstream. It was not a perfect solution, but it seemed to markedly cut down the turbidity in the ditch. Before and after photos can be seen in Figure 13 and 14.

Figure 14 After the culvert was installed.
